# brookview (bulyea heights) community enhancement report

march 2015

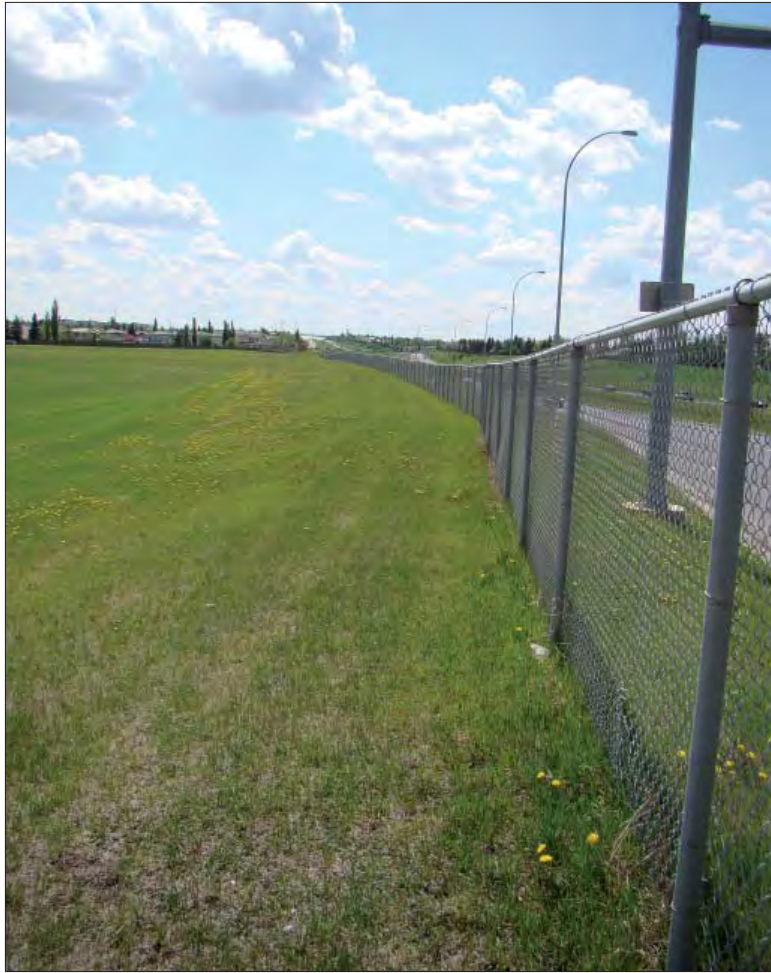
Traffic noise from nearby Terwillegar Drive is quite noticeable due to the absence of any buffer such as sound attenuation fencing or mounding. In addition, there is the absence of any type of shade trees along the western edge of the site next to Terwillegar Drive. This results in a lack of shaded areas and exposure to prevailing winds from the northwest and southwest (photo 13).

Photo 13: School ground adjacent to Terwillegar drive

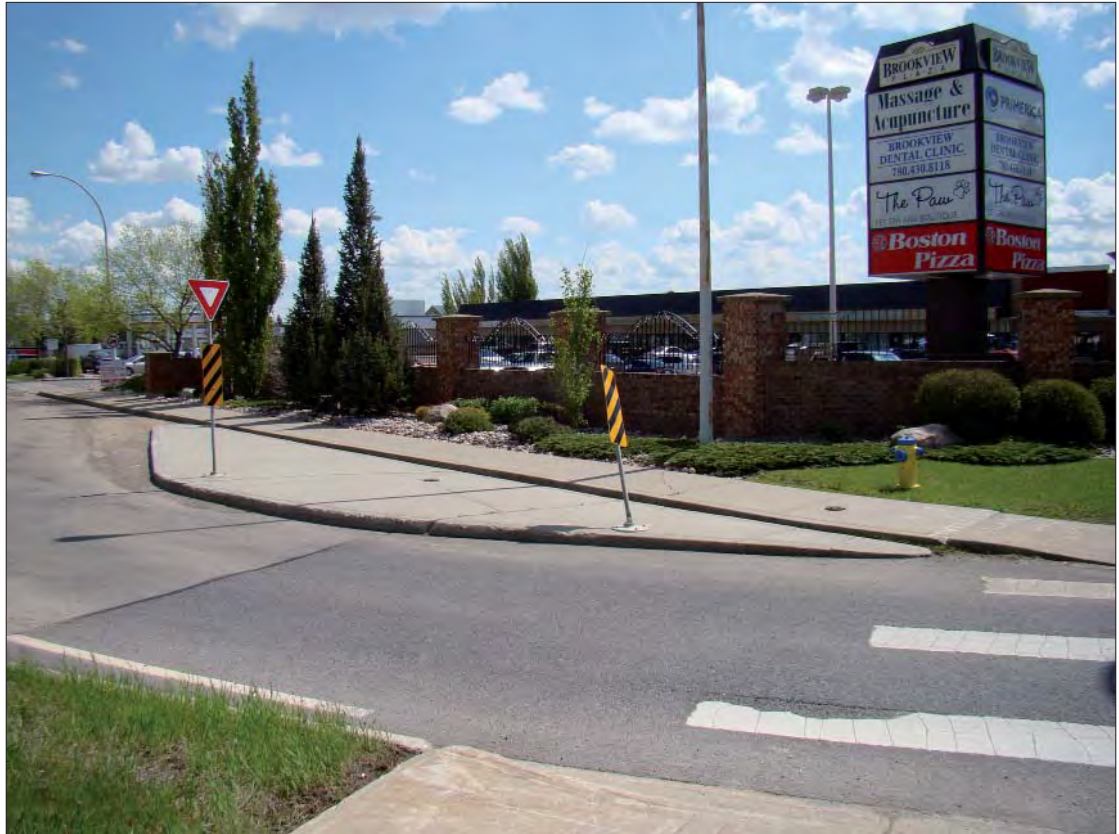
The Terwillegar Drive entry consists of masonry and brick pillars with low walls and signage. The masonry extends North and South for some distance along Terwillegar Drive making this area the major entrance to the neighbourhood (photo 25). Trees and low shrub planting are located in the Bulyea Road median and boulevards (photo 26). The visual impact of this neighbourhood entry is somewhat lost due to its scale, its location at a major intersection, an adjacent commercial plaza and the presence of considerable fast moving vehicular traffic (photo 27).

Photo 27: Entry feature at Terwillegar Drive and Bulyea Road, with commercial buildings in the background.

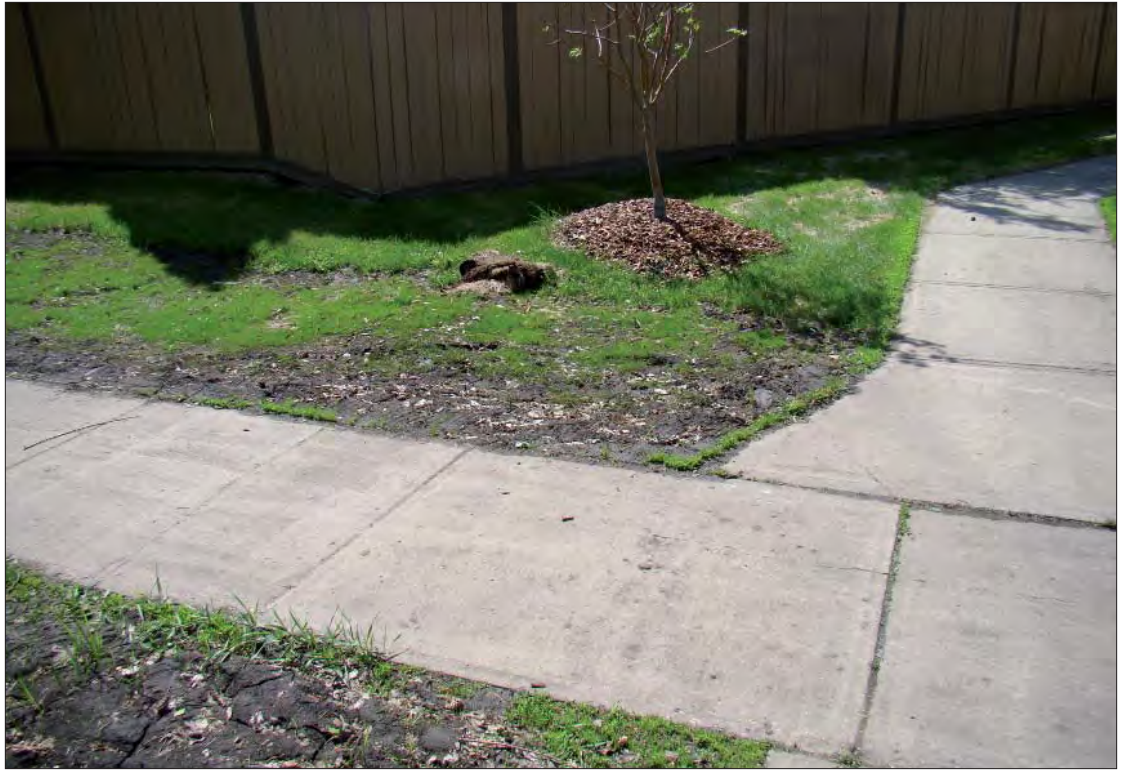
The grounds owned by the Community League are generally well maintained when compared with sections owned and maintained by the City of Edmonton. Trees are in good conditions although some are damaged or show signs of disease, probably due to their advanced age. Further investigation into tree health should be undertaken by a qualified arborist. Turf areas are well maintained and are in good condition with the exception of a few areas damaged by winter walkway maintenance or heavy pedestrian traffic (photos 28 and 29).

Photo 28: Typical turf damage caused by winter maintenance.

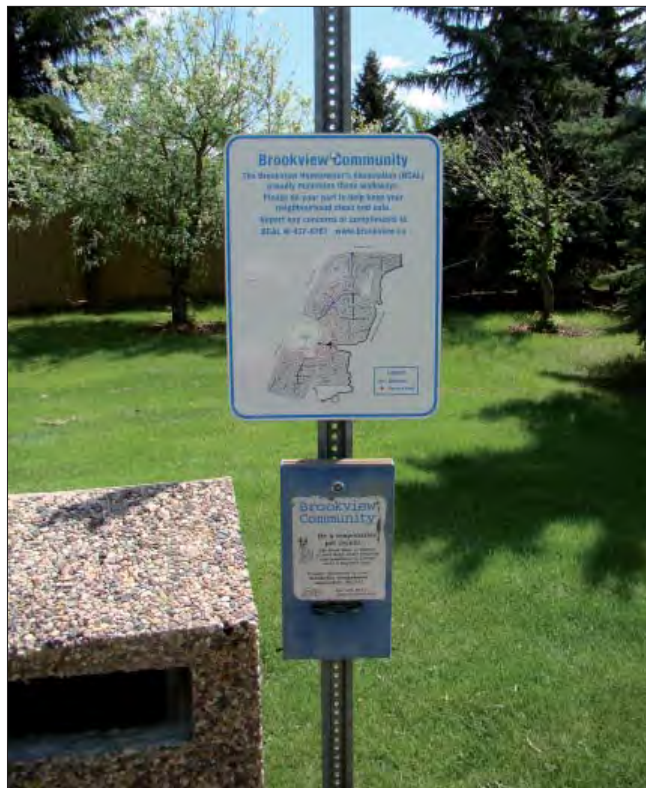
Site amenities (benches, trash receptacles, signage, etc.) are minimal and show signs of deterioration and most are made of exposed aggregate which gives them a dated look (photo 30). The existing site amenities should be replaced or updated, and the number of benches in the walkways should be increased. Some walkway sections consisting of large turf expanses could accommodate additional benches, signage and small plazas (photo 31).

Photo 30: Typical signage and trash receptacle found throughout the community. Note the signs of corrosion on signage.

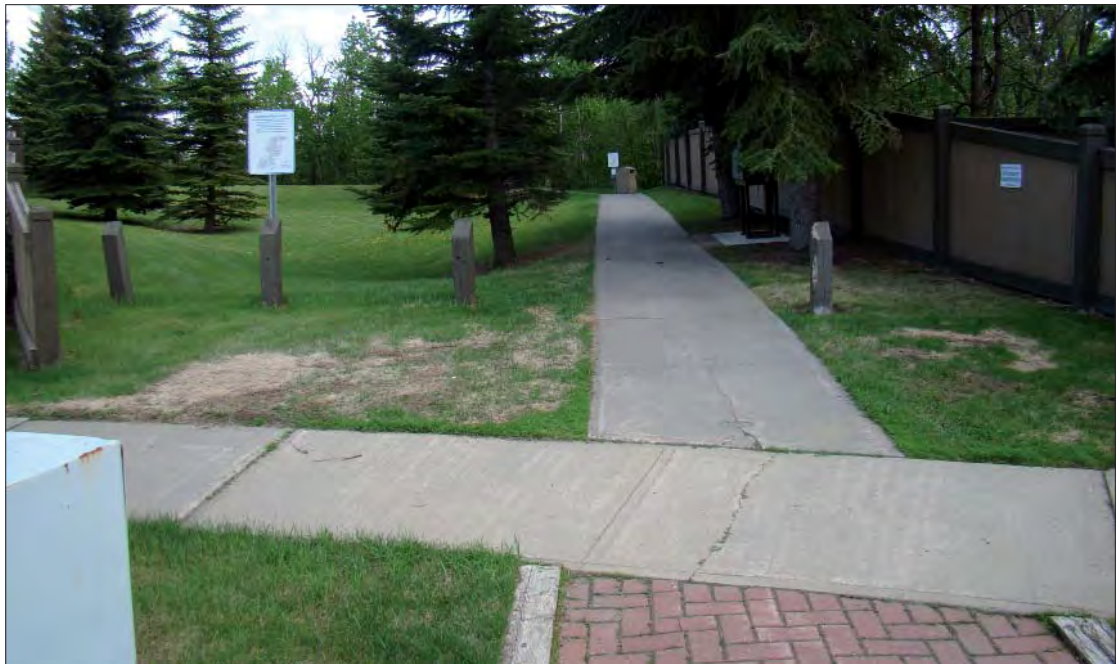
The concrete walkways are in fairly good condition. However some damaged areas, mostly cracked or missing concrete, should be repaired before they become tripping hazards for pedestrians (photo 32). Numerous areas where multiple walkways intersect present an ideal opportunity to install additional benches or create small nodes and plazas. Interpretive or directional signage could also be installed at these intersections (photo 33).

Photo 32: Concrete walkway showing signs of deterioration (cracking).

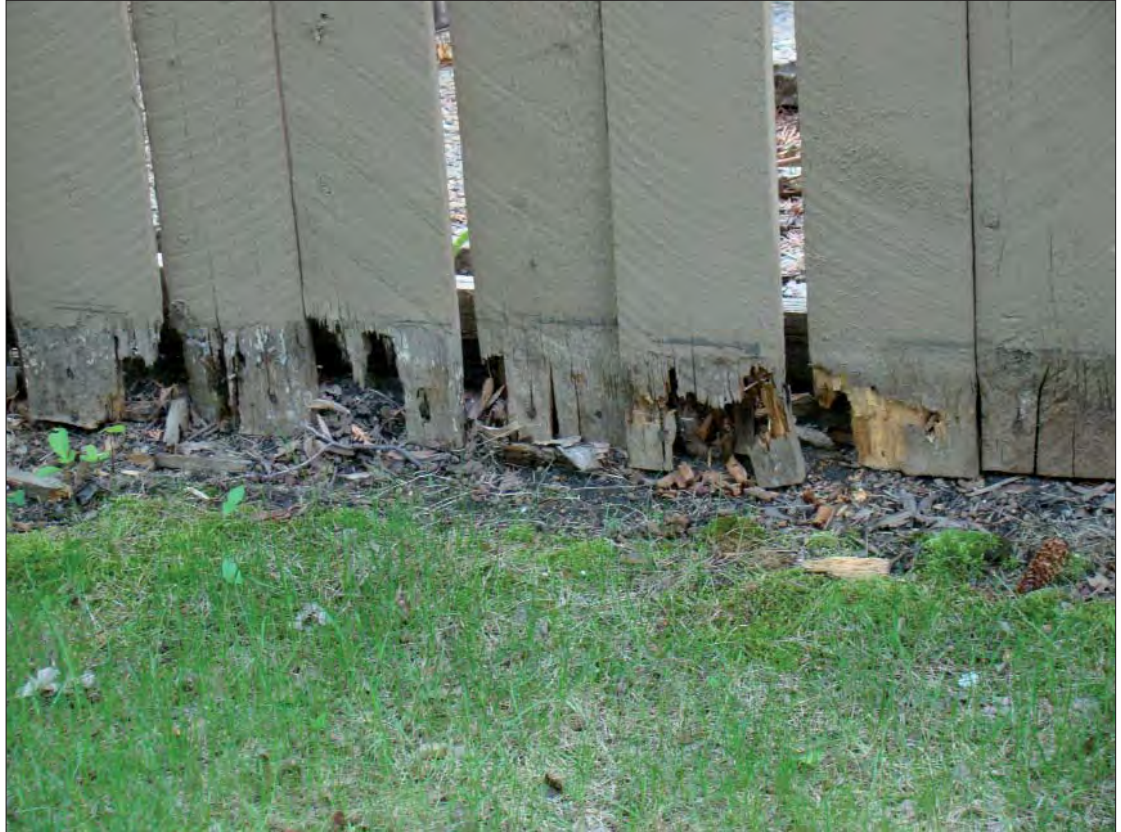
The state of the pathway lighting and wood screen fencing are two elements that stand out in our site analysis as requiring the most immediate attention. The wood fencing is exhibiting signs of advanced deterioration such as fading and rotting posts, boards and stringers (photo 34). It is our understanding that this issue and a replacement strategy are presently the subject of discussions between the executive committee and the residents of Brookview.

Photo 34: Wood fencing showing signs of advanced deterioration.

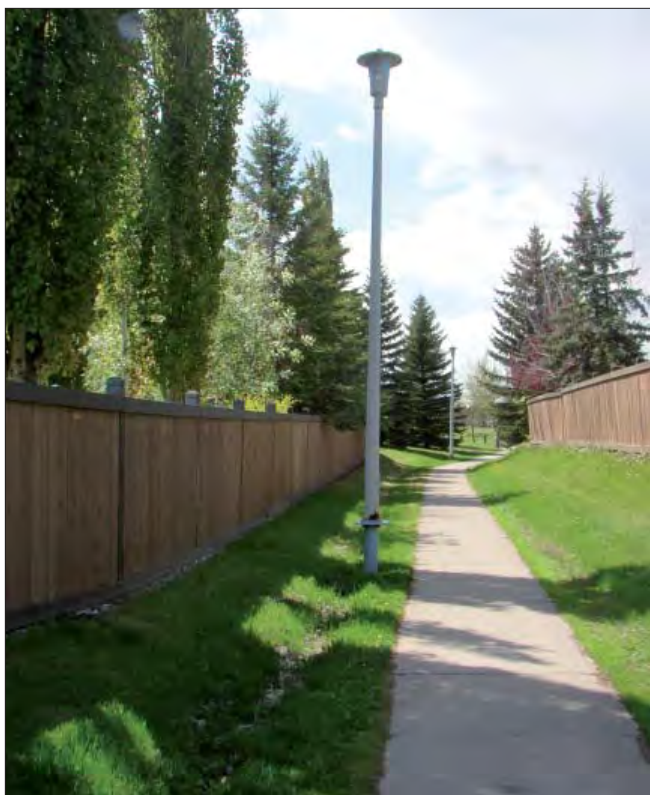
The pathway lighting also seems to have reached its normal use cycle. Most of the light post's powder coated paint is faded (photo 35). A considerable number of posts show signs of metal corrosion and damage. In some cases, wires were observed protruding from the base of the light poles (photo 36). In addition, the style and type of lighting is dated and inefficient. More efficient lighting, such as Light-Emitting Diode (LED), should be considered when replacing the walkway lighting. This will not only lead to better lighting patterns but will also help reduce operating costs by using less power.

Photo 35: Walkway lighting. Note corrosion at base of pole.

ITEM	DESCRIPTION	COMMENTS
1	Walkway Lighting - All Areas	<ul style="list-style-type: none"> <li>Light poles show advance stage of deterioration and should be replace as soon as possible</li> </ul>
2	Community Sign Illumination	<ul style="list-style-type: none"> <li>Steps already taken to have sign illuminated in 2015. Electrical contractor hired.</li> </ul>
3	Plazas	<ul style="list-style-type: none"> <li>Build one plaza (e.g. across from school) as a "pilot" project and to allow feed back from community. First plaza should be built in high visibility area.</li> <li>Subsequent plazas could be built one area at a time, as opposed to a few plazas in various areas.</li> </ul>
4	Nodes	<ul style="list-style-type: none"> <li>Nodes could be built after or simultaneously with the plazas. As with the plazas, it is recommended that all nodes in one area be built before moving on to nodes in other areas.</li> </ul>

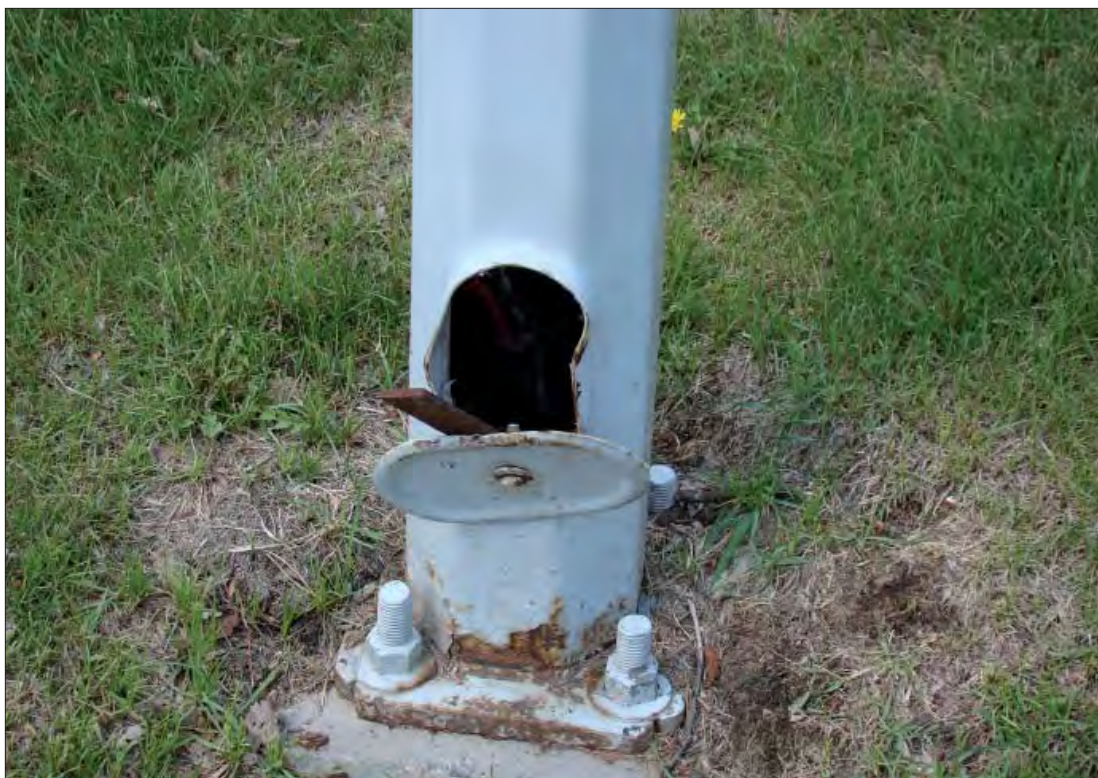
Photo 36: Walkway lighting with corrosion and exposed wires.
