# brookview (bulyea heights) community enhancement report

march 2015

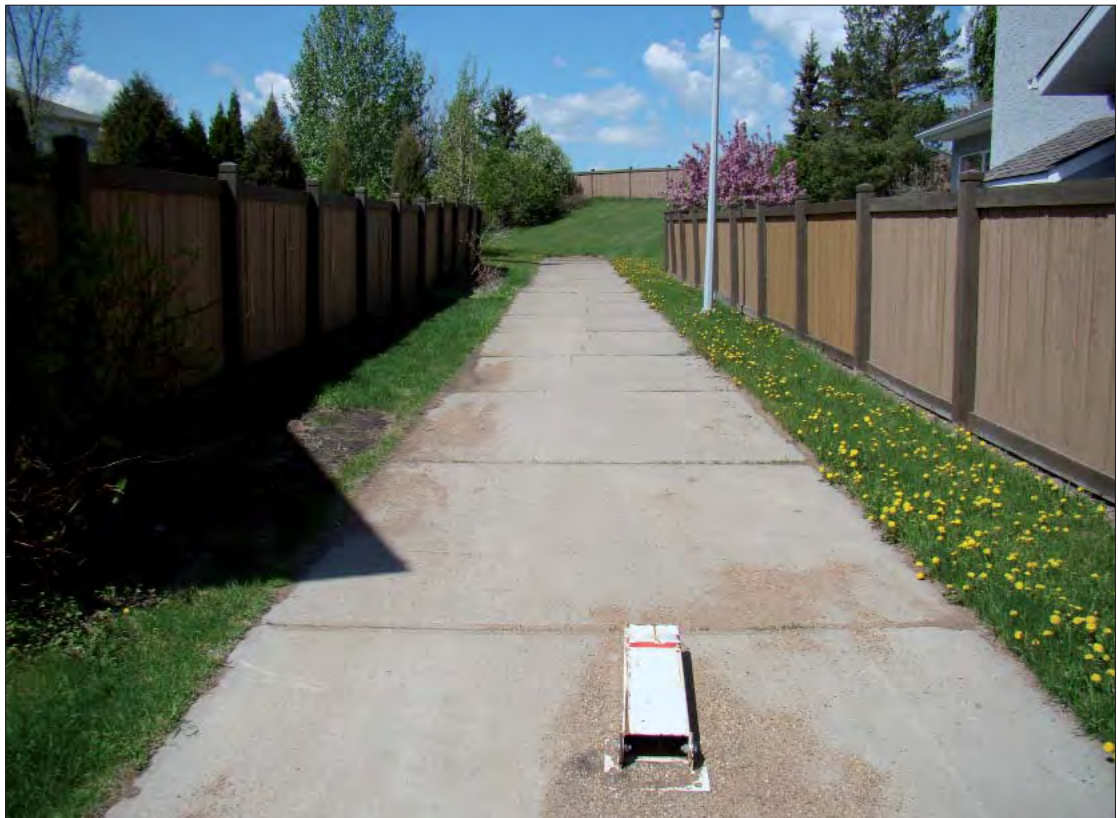
Photo 1: Area 1 Walkway, North of Butterworth Way

Located in the north part of the community, the majority of the walkways in this area are owned and maintained by BCAL with the exception of a small portion off Butterworth Way, which is maintained by the City of Edmonton (photo 1). The character of this area reflects a naturalized landscape with native trees and understory, particularly in the north part above Burton Road (photo 2). The south part of the area is of a similar park like character as seen throughout the rest of the community (photo 3). Fencing consists of decorative steel for the lots backing onto the naturalized area and lighting is provided by pedestrian scale light posts. The character is reminiscent of the Whitemud Ravine located east of the area. Sight lines are relatively good with the exception of a few areas in the naturalized portion where dense vegetation obstructs views from the walkway.

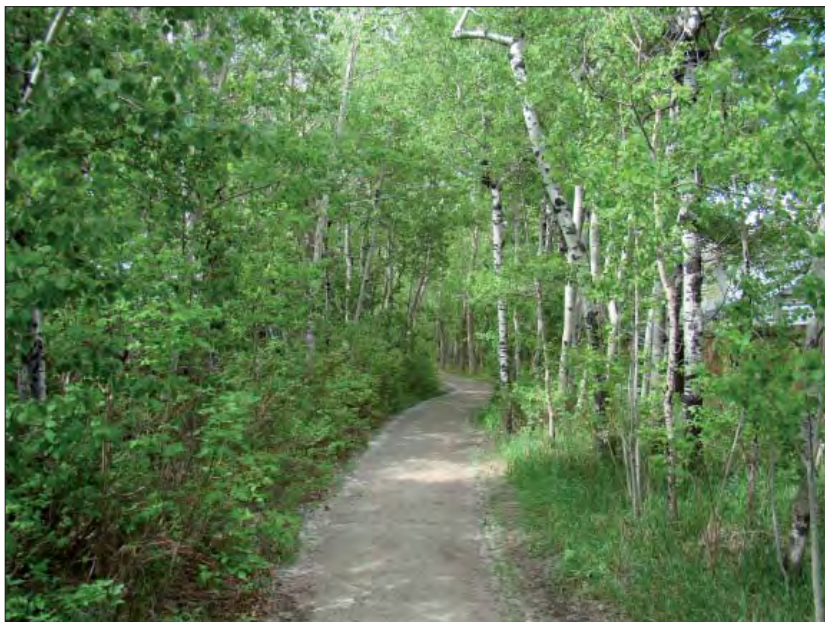
Photo 7: Area 2 Walkway, South of Burton Road. Note the dense vegetation and naturalized character.

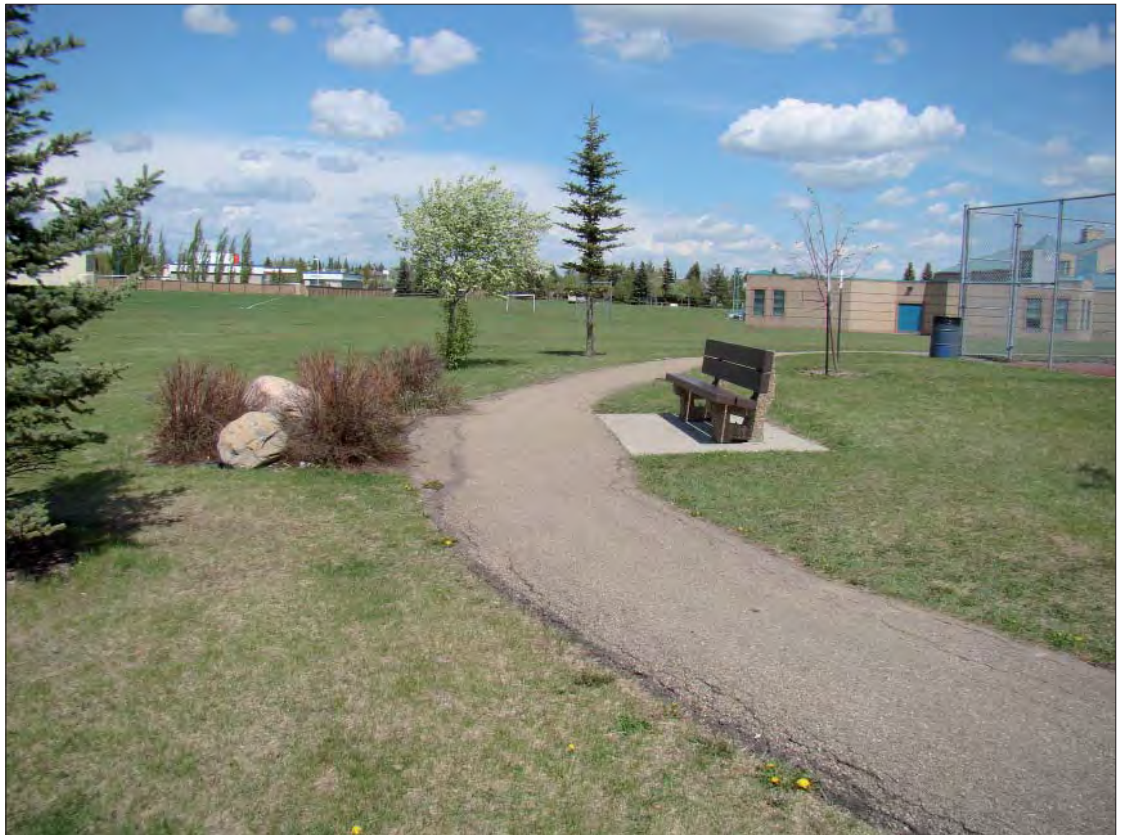
Photo 12: School site walkway, looking North

Traffic noise from nearby Terwillegar Drive is quite noticeable due to the absence of any buffer such as sound attenuation fencing or mounding. In addition, there is the absence of any type of shade trees along the western edge of the site next to Terwillegar Drive. This results in a lack of shaded areas and exposure to prevailing winds from the northwest and southwest (photo 13).

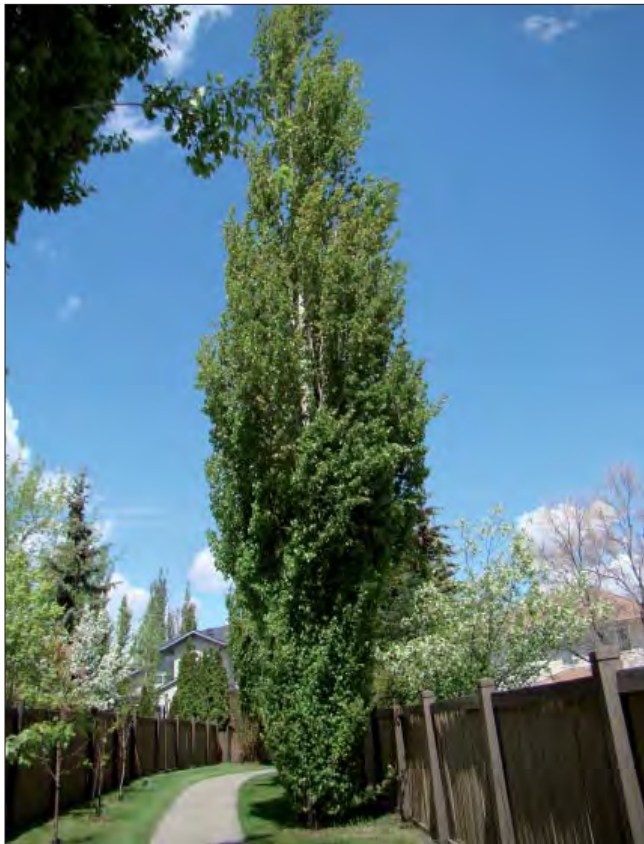
The grounds owned by the Community League are generally well maintained when compared with sections owned and maintained by the City of Edmonton. Trees are in good conditions although some are damaged or show signs of disease, probably due to their advanced age. Further investigation into tree health should be undertaken by a qualified arborist. Turf areas are well maintained and are in good condition with the exception of a few areas damaged by winter walkway maintenance or heavy pedestrian traffic (photos 28 and 29).

Photo 29: Healthy turf area in walkway and mature deciduous tree.

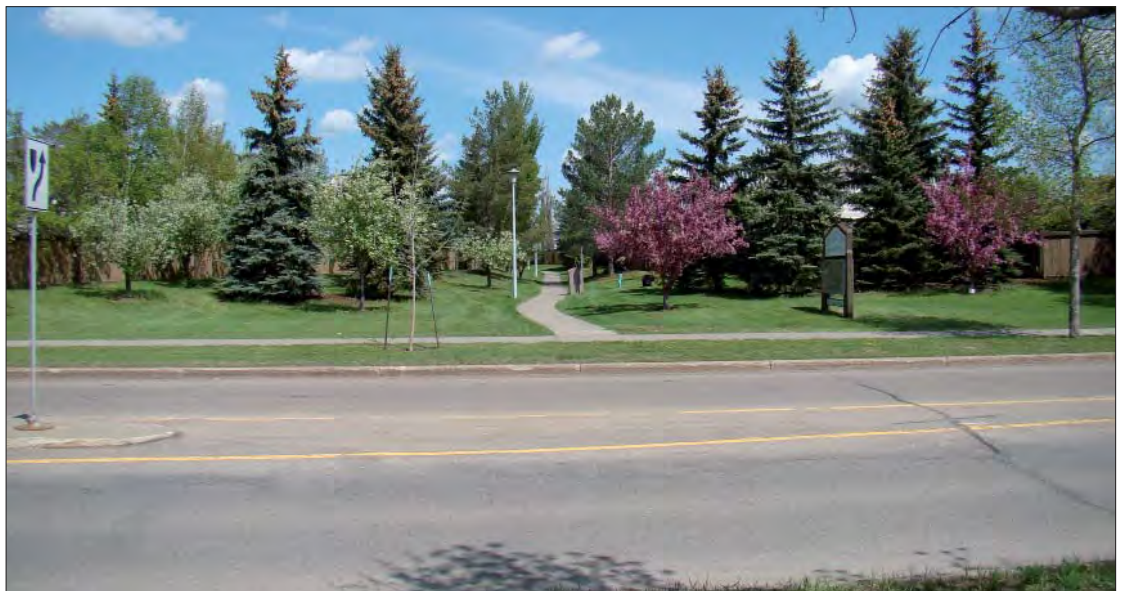
Site amenities (benches, trash receptacles, signage, etc.) are minimal and show signs of deterioration and most are made of exposed aggregate which gives them a dated look (photo 30). The existing site amenities should be replaced or updated, and the number of benches in the walkways should be increased. Some walkway sections consisting of large turf expanses could accommodate additional benches, signage and small plazas (photo 31).

Photo 31: Walkway at southwest centre of Area 2. Large open space could accommodate a plaza and other amenities.

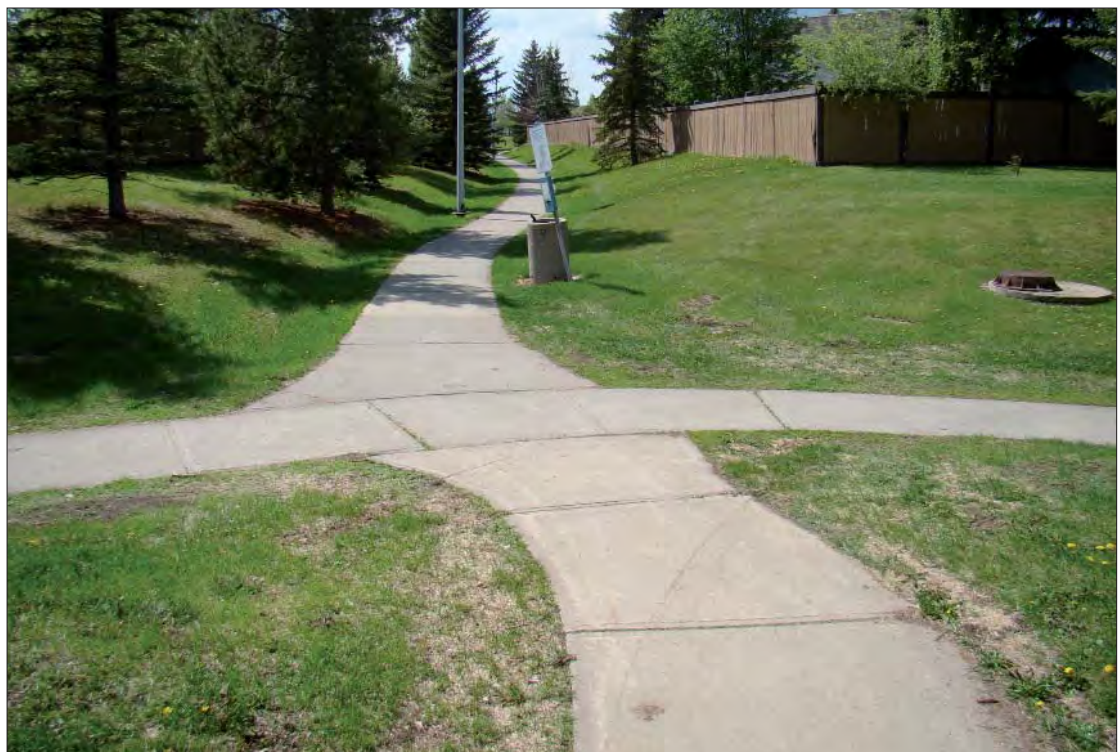
The concrete walkways are in fairly good condition. However some damaged areas, mostly cracked or missing concrete, should be repaired before they become tripping hazards for pedestrians (photo 32). Numerous areas where multiple walkways intersect present an ideal opportunity to install additional benches or create small nodes and plazas. Interpretive or directional signage could also be installed at these intersections (photo 33).

Photo 33: Walkway intersection. Note the open space that could accommodate a node or plaza.
